AGENDA
LAKEWOOD CITY COUNCIL
STUDY SESSION
CITY OF LAKEWOOD, COLORADO
VIRTUAL MEETING
AUGUST 3, 2020
7:00 P.M.

Subject: **INITIAL STUDY SESSION PRESENTATION OF A 14.27 BLIGHT DESIGNATION
CONSIDERATION FOR THE PROPERTY LOCATED AT 1347 LAMAR ST**

Property Conditions Assessment (Blight Study) for 1347 Lamar Street Lakewood, Colorado March 2020

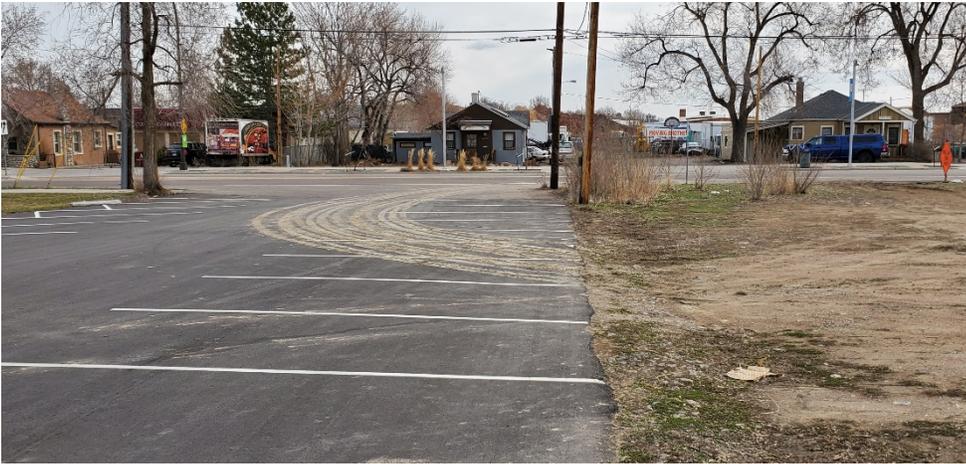
The Study Area is located along Lamar Street, a local primary street located in an area that has seen resurgent growth over the past few years. Curb and gutter and sidewalks are not present along Lamar Street at the Study Area, and access to the property from the paved roadway is undefined, unpaved, and rutted, with no curb (and therefore no curb cuts) to indicate a point of access. Additional access is present from the parking lot of the adjacent parcel where evidence of overflow parking and vehicle turnarounds was observed during the site reconnaissance. Because the access points connect non-paved and paved areas, issues such as the tracking of mud onto the street and erosion at the access points creates, at best a nuisance issue for both the City (Lamar Street access) and the adjacent property (World Church).

Photo 1: Access to the Study Area from the adjacent parcel with mud tracking

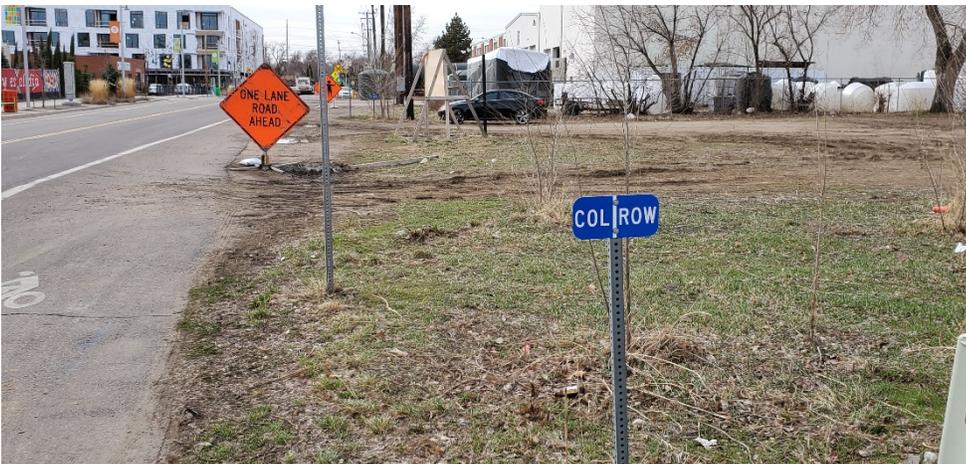
The lack of sidewalks and other pedestrian provisions along the roadway may also cause unsafe condition for local pedestrians.

Photo 2: Undefined, unmarked access along Lamar Street, and no sidewalks

Due to the lack of appropriate site access, a lack of sidewalks, a lack of curb and gutter, and potential safety concerns for pedestrians, **Blight Factor: Predominance of Defective or Inadequate Street Layout is present.**

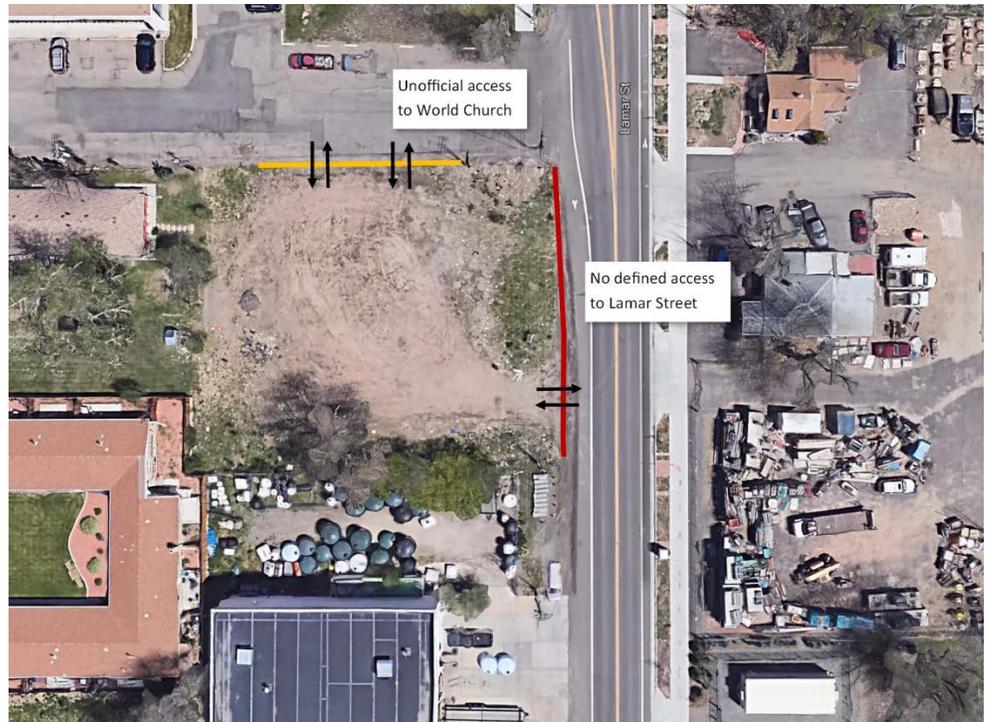
Photo 1: Access Limitations for the Study Area

The main issue for the Study Area, as discussed, is a lack of adequate accessibility to the property from Lamar Street and an unconventional, unsupported access from the adjacent property. Prior to development, a defined point of access will need to be designed and completed.

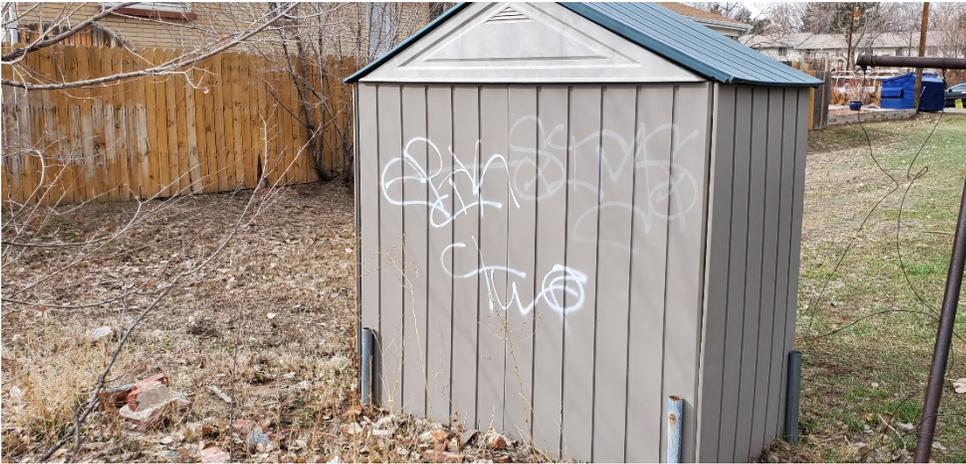
Photo 1: Graffiti was identified along the Study Area property line

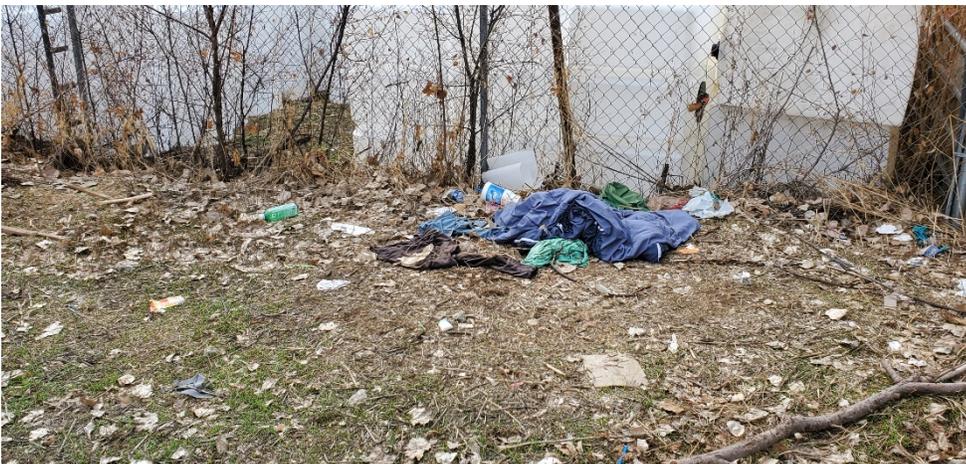
Photo 2: Evidence of Homelessness within the Study Area boundary

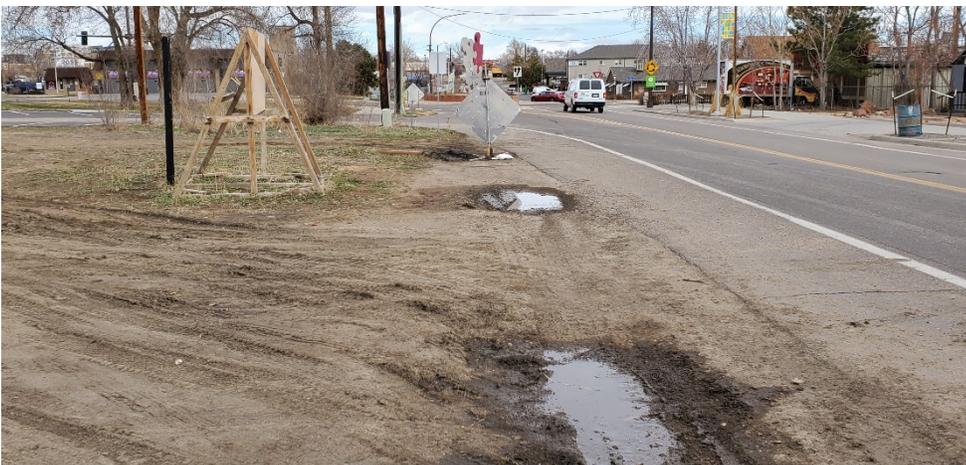
Photo 3: Lack of sidewalks and stormwater drainage (no curb and gutter)

- Inadequate lighting. A lack of street lamps on the west side of Lamar Street or other site lighting may increase the risk of crime or may indicate a safety risk between dusk and dawn.
- Lack of sidewalks. A lack of sidewalks along Lamar Street could present a safety risk for pedestrians in the area.

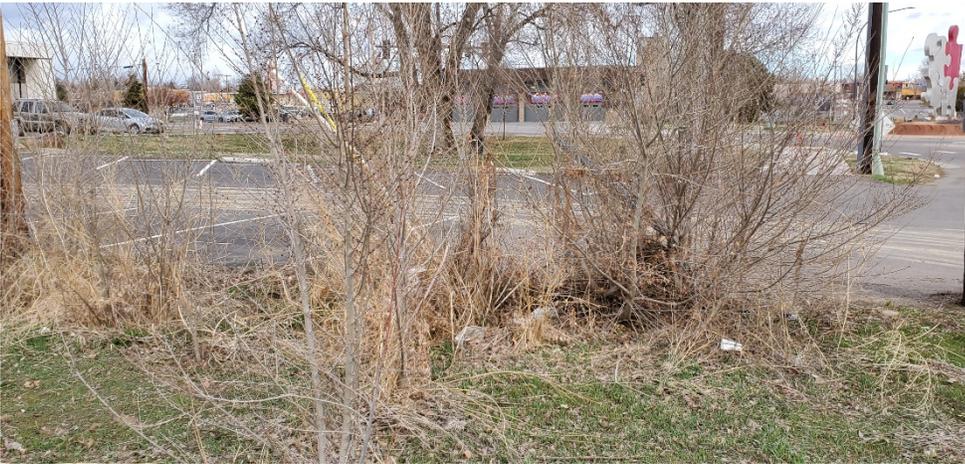
Photo 1: Unkempt, unmaintained vegetation at the Study Area

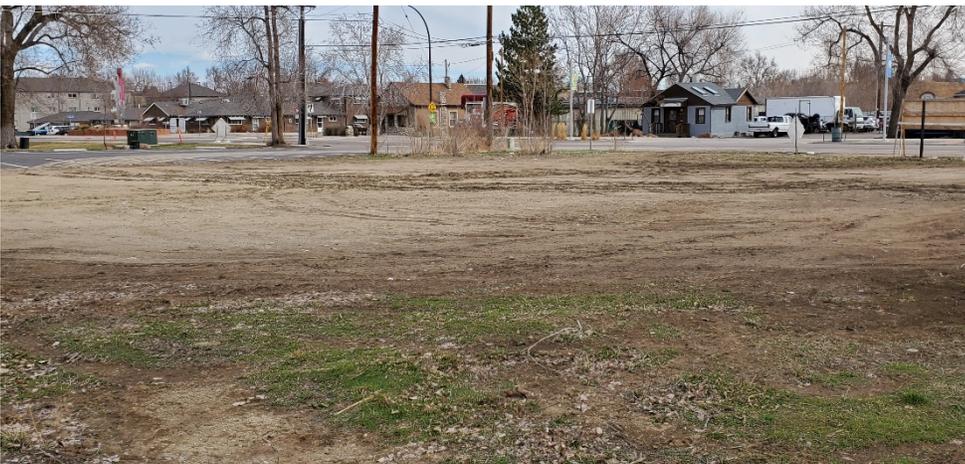
Photo 2: The Study Area is unmaintained and no site improvements are present

Based on the lack of site maintenance and improvements within the Study Area, **Blight Factor: Deterioration of Site or Other Improvements is present.**

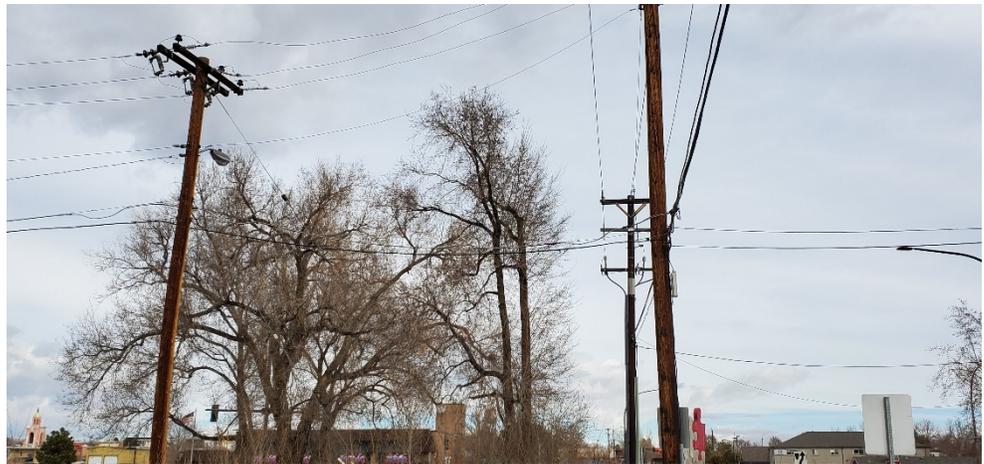
Many deficiencies in infrastructure, public improvements, and utilities were identified within the Study Area boundary. The main issues observed during the site reconnaissance included a general lack of public improvements (no stormwater protections, no curb and gutter, no sidewalks) and potentially developmentally prohibitive overhead utilities.

Photo 1: Overhead utilities exist on the north and east side of the parcel.
