AGENDA
LAKEWOOD CITY COUNCIL
STUDY SESSION
CITY OF LAKEWOOD, COLORADO
VIRTUAL MEETING
AUGUST 3, 2020
7:00 P.M.

Subject: **INITIAL STUDY SESSION PRESENTATION OF A 14.27 BLIGHT DESIGNATION
CONSIDERATION FOR THE PROPERTY LOCATED AT 1347 LAMAR ST**

Property Conditions Assessment (Blight Study) for 1347 Lamar Street Lakewood, Colorado March 2020

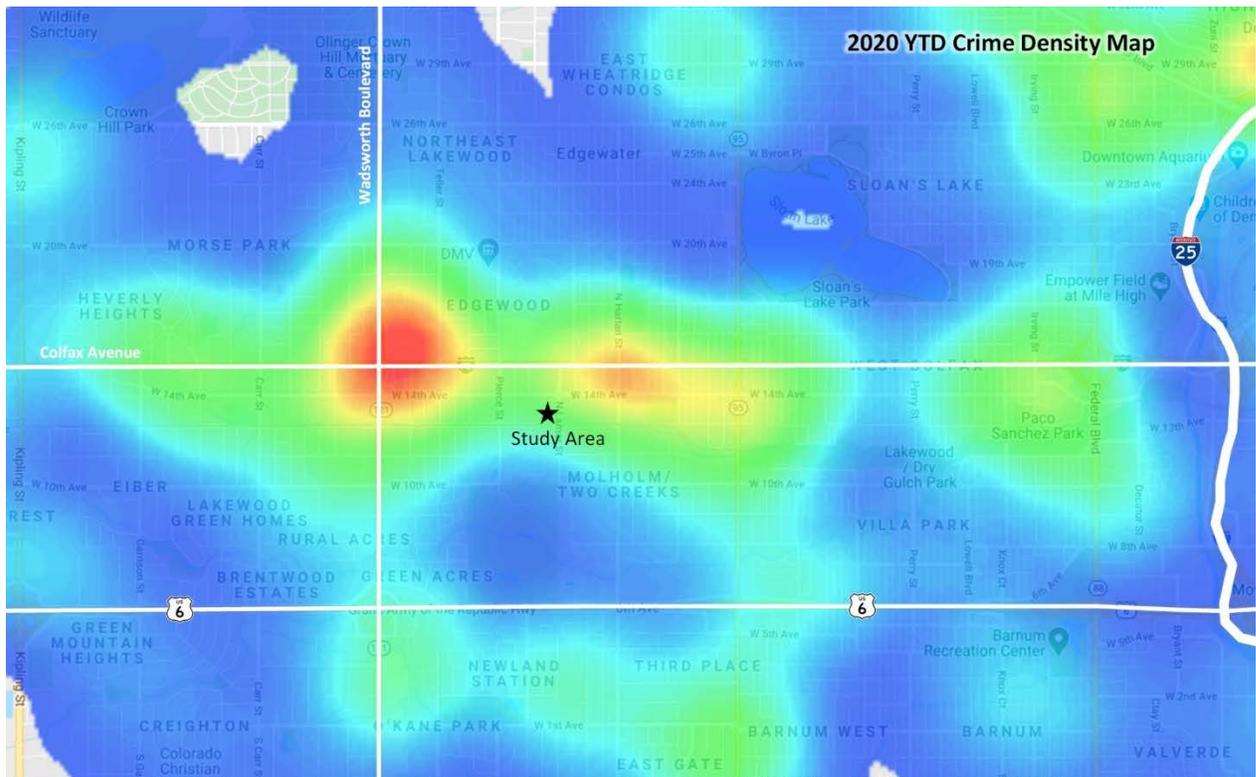
Figure 5.1 2020 Year to Date Crime Density Map

Matrix reviewed the interactive Community Crime Map for 2020 (year to date) to further analyze crime data for the Study Area and surrounding areas. As indicated on the crime concentration map (Figure 5.1), the Study Area is in an area of increased crime risk being near higher crime areas along Colfax Avenue at Wadsworth Boulevard and Harlan Street.
